INTERNATIONAL PACKINGS  
CORPORATION

LOWER DAM  
NH-00480

PHASE I INSPECTION REPORT  
NATIONAL DAM INSPECTION PROGRAM

06 28 050 APRIL 1979

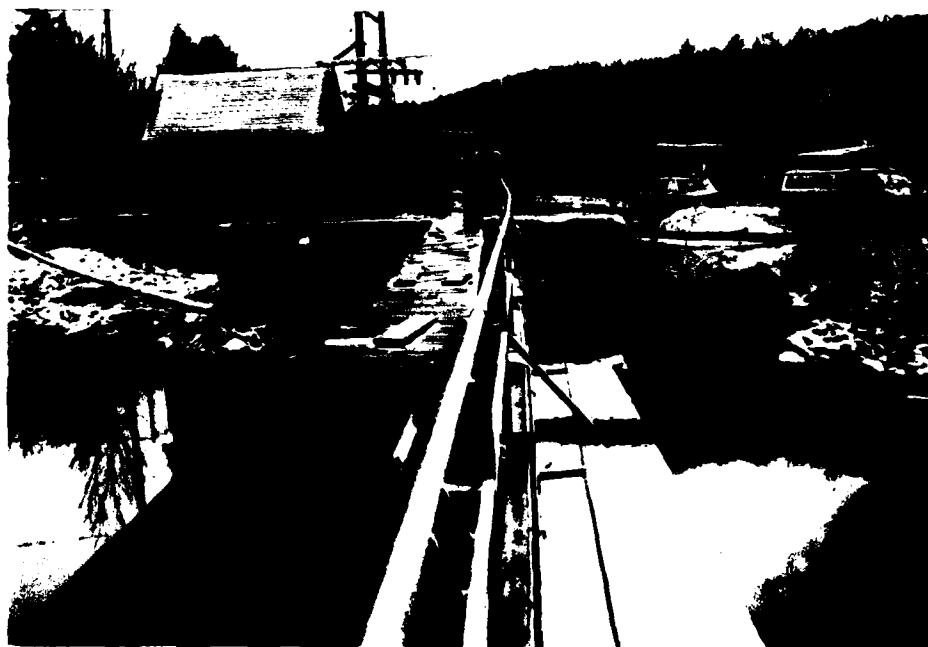
- (a) The spillway section and downstream apron of the dam show evidence of settlement and deflection downstream. Settlement of the apron of at least 4 inches has occurred (see overview photograph). Downstream deflection of the stop log section of the spillway of 5 to 7 inches at its' center is evident. (see Appendix C, photograph 2)
- (b) Significant scour has occurred downstream of the apron below the spillway. (see photograph 9) Some undermining of the timber cribs is evident.
- (c) Direct leakage from the upstream face of the dam to the downstream toe is occurring. This was evidenced by eroded depressions and flow

2  
VIEW OF SPILLWAY STRUCTURE FROM NORTH END; NOTE DEFLECTION  
OF STRUCTURE TOWARD DOWNSTREAM

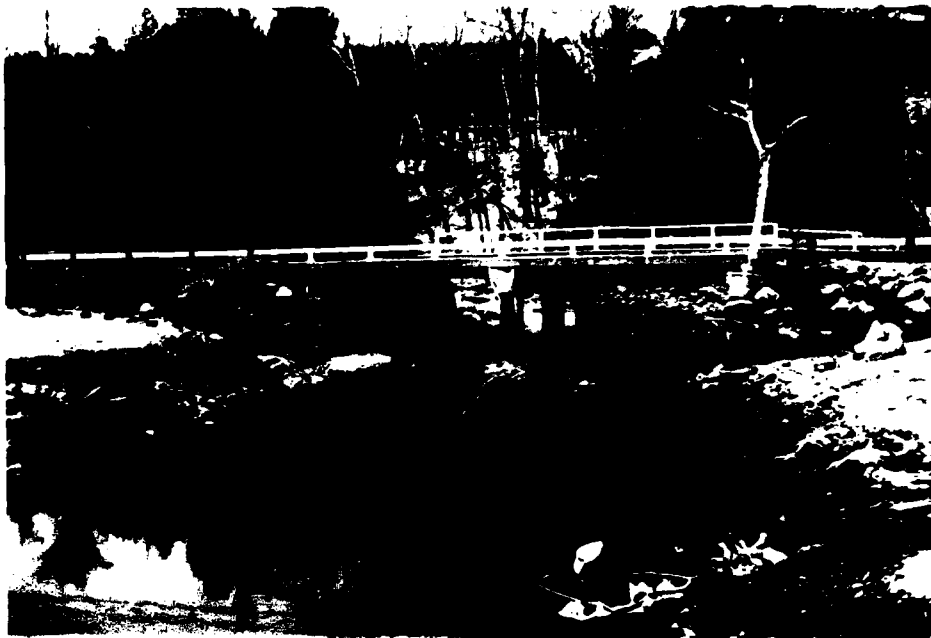
The Route 3A highway bridge located approximately 150 feet above the dam causes a restriction in the approach channel to the dam.

8  
BRIDGE IMMEDIATELY UPSTREAM FROM DAM
